## Maxum II

## Maxum edition II Analyzer General Maintenance

General Analyzer Functions, Troubleshooting, and Maintenance for Maxum II Gas Chromatographs. The information in this manual supercedes the applicable topics in previous manuals.

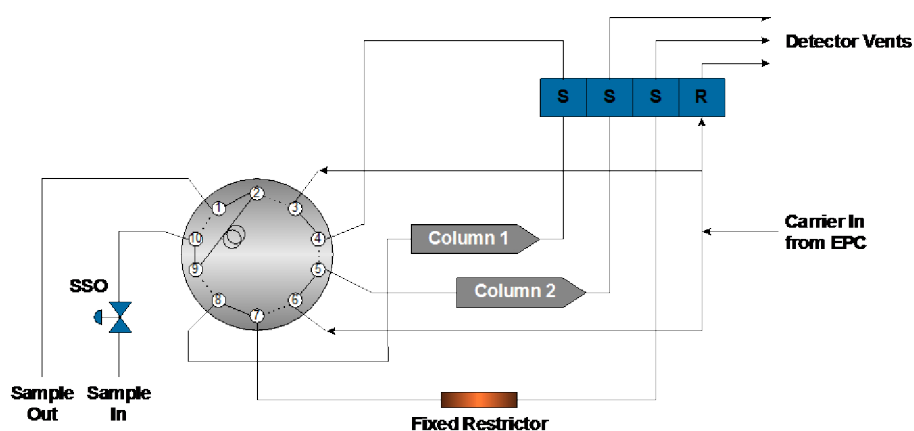
Figure 3-1 Example Applet

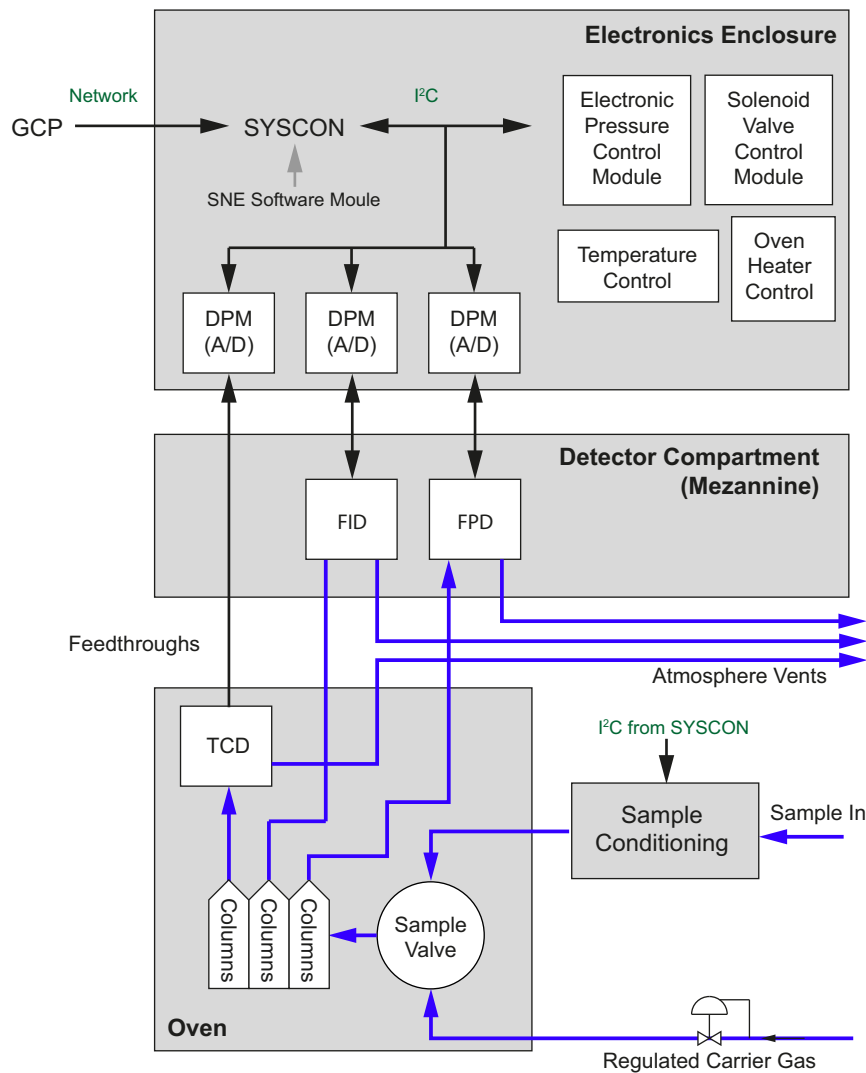
This section provides an overview of the operation of the Maxum II analyzer. The examples show a Maxum II Airless/Airbath model in order to include many optional features. Most analyzers will have only some of these features; for example, the Modular Oven model has no detector compartment.

The operational block diagram shows how a sample is processed within the analyzer. The SNE functions are performed in software in new systems; older systems still have hardware versions.

Figure 3-2 Operational Block Diagram (Maxum II Airless Airbath model shown)

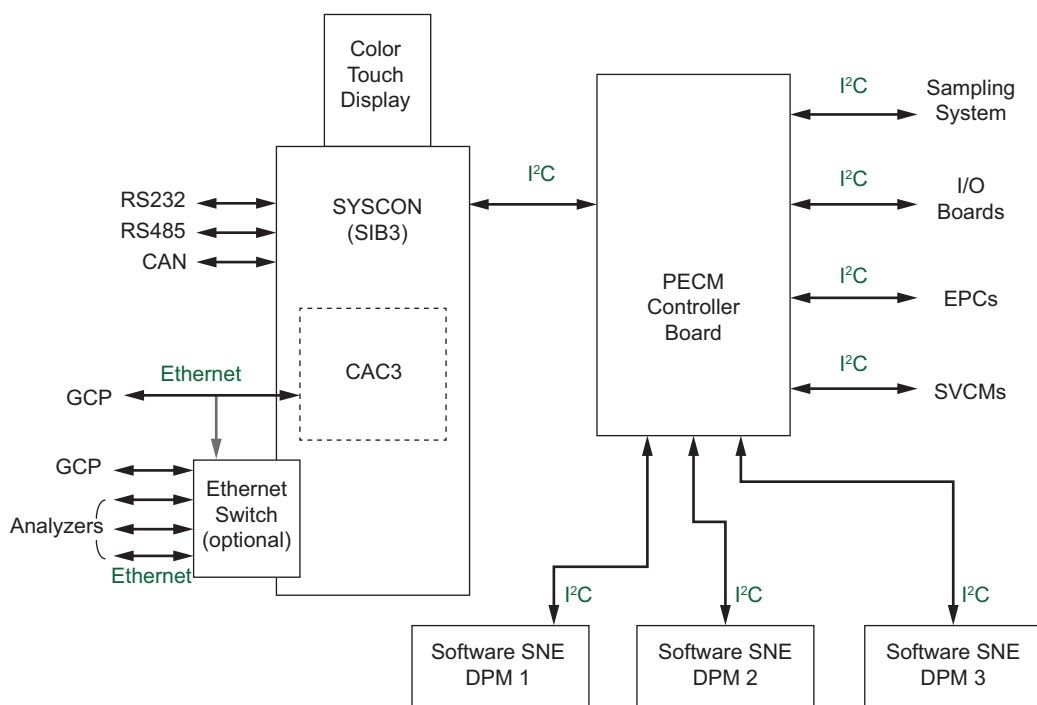
An I<sup>2</sup>C Internal Bus provides communication between the SYSCON, SVCM, EPC, PECM and to the I/O bus. External communication is through an Ethernet link. The interface for each type of module is described in the Component Descriptions and Maintenance Procedures section.

Figure 3-3 Data Communication Paths

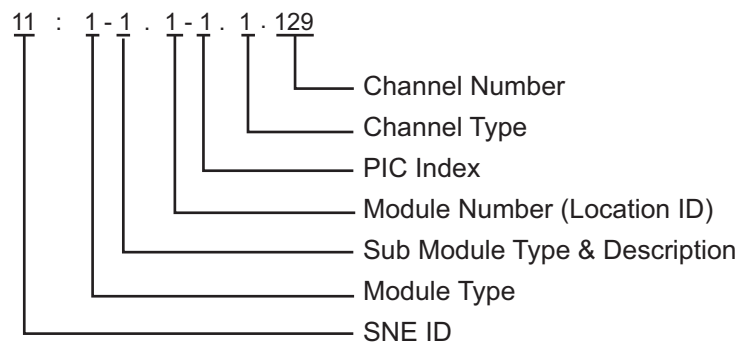
All modules within the Maxum II electronic compartment have a unique identification number as related to the software SNE module which controls them. The identification relationship between the SNE and the modules it controls is referred to as the SNE ID String.

Figure 3-4 Identification Number

Address information is located in the analyzer local I/O Table. The I/O points are identified by module type, mounting location within the electronic compartment and channel number. This allows module addressing from either the SYSCON database, SNE Tables or from Advance Database.

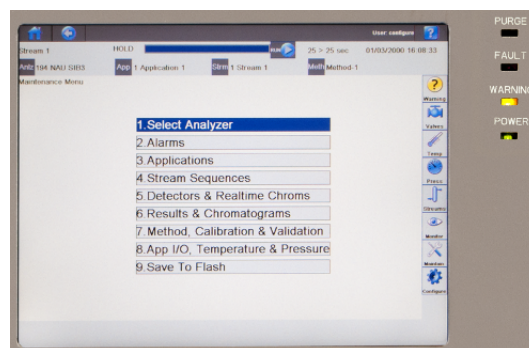
The color touchscreen displays all maintenance functions and data in a graphical display. In addition it can also display both real-time and stored chromatograms. The stored chromatograms include voltages and cycle times for future comparison as well as zoom and pan features. Operational and routine maintenance tasks for the analyzer can be performed from the color touchscreen interactive display screens and menus. System security is assured with multiple levels of password protection for all analyzer-operating functions.

A color touchscreen emulator (also called a Human Machine Interface, or HMI, emulator) is available from the Maxum Gas Chromatograph Portal (GCP) software. This emulator allows a user to perform color touchscreen tasks without being located at the unit.

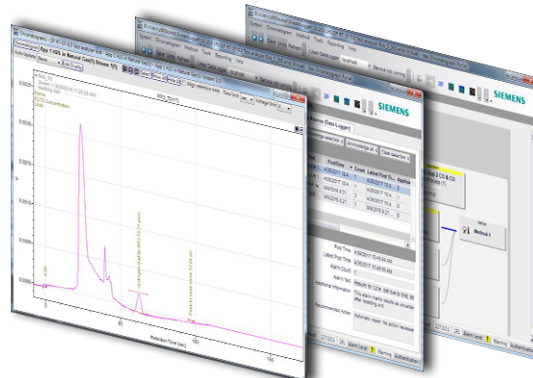
The Maxum II uses a PC based network workstation for programming and data processing. Analyzers can be programmed and monitored from a single location, and, like the color touchscreen, the workstation includes graphical displays for operation, maintenance, and diagnostics. It also supports PC printers to print chromatograms and alarm logs in order to meet record keeping requirements.

The Maxum II workstation software, Gas Chromatograph Portal (GCP), is designed for PCs with Microsoft® Windows operating systems. PC workstations can be connected through existing LANs for wide access to monitoring or maintenance tasks. The graphical interface recognizes and displays all network hardware. The system monitors the alarm status of all analyzers connected to the network to centralize system maintenance. More information can be found in the Gas Chromatograph Portal User Manual (A5E03944542001) at <https://support.industry.siemens.com/cs/document/109745485/gas-chromatograph-portal-user-manual-maxum-microsam?lc=en-WW&pnid=17741> (<https://support.industry.siemens.com/cs/document/109745485/gas-chromatograph-portal-user-manual-maxum-microsam?lc=en-WW&pnid=17741>).

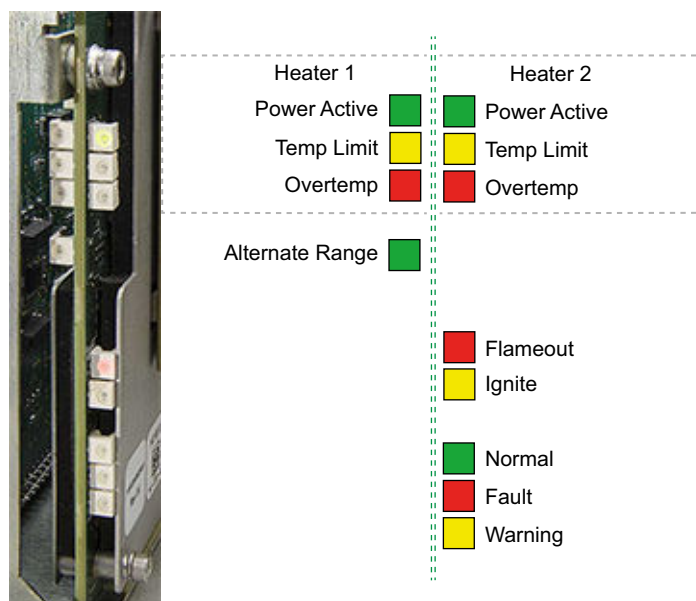
Figure 4-1 Base3DPM Status LEDs

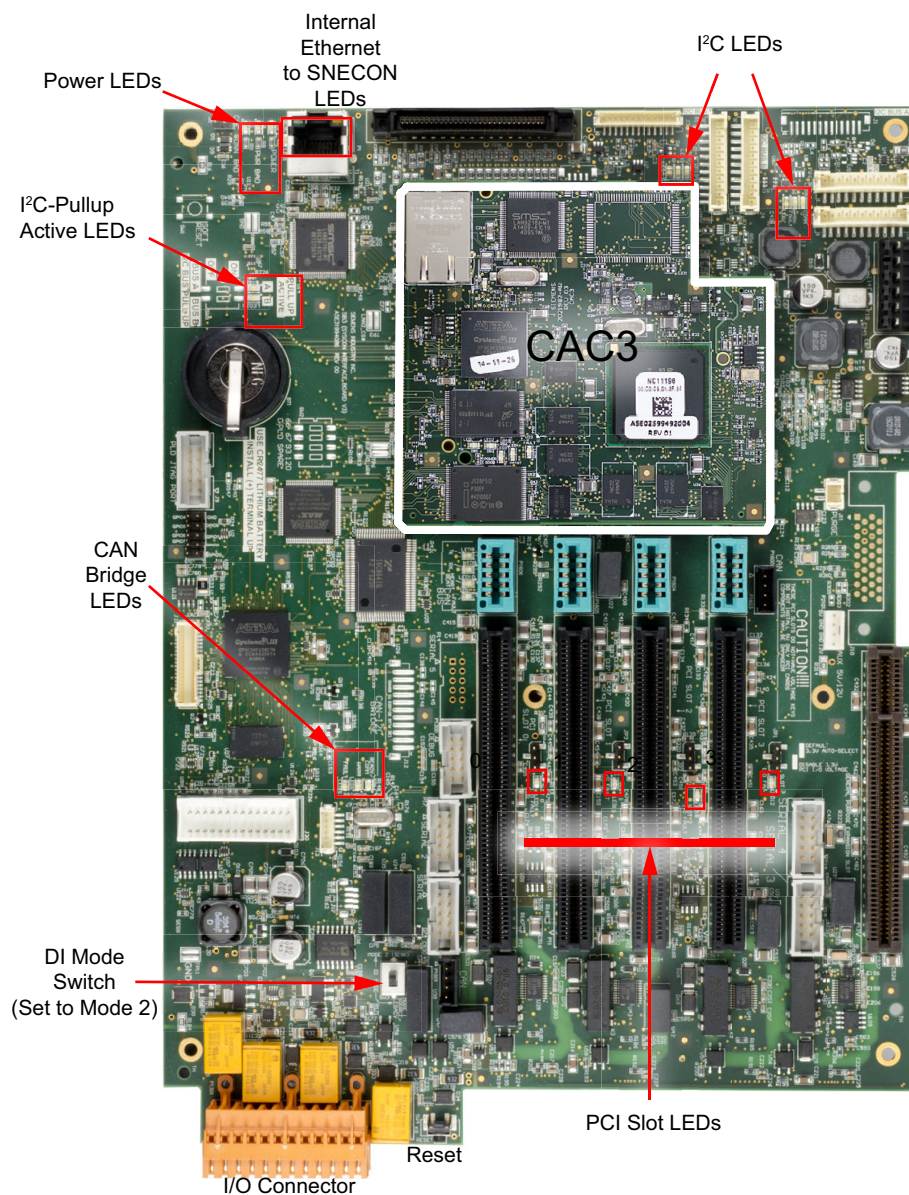
The SIB3 has several LEDs that indicate useful information about the operating status of various interfaces.

Figure 4-2 SIB3 LEDs and Switches

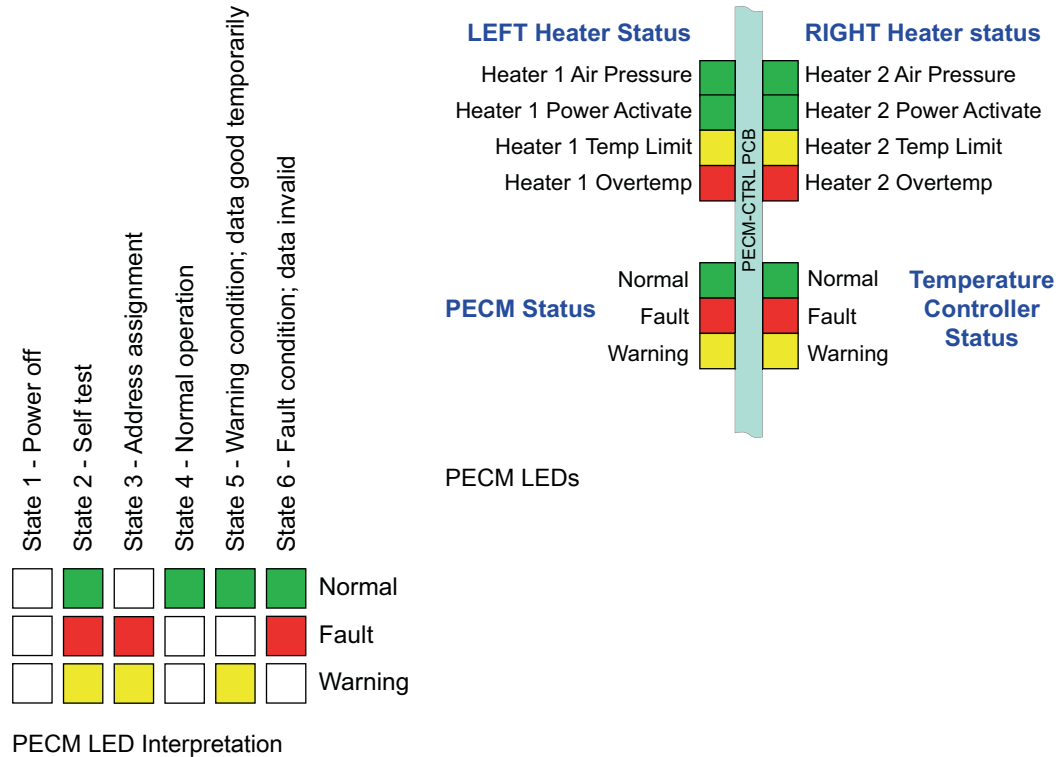
The LEDs on the PECM board can help with troubleshooting problems. There are two sets of LEDs: one on each side of the front board as shown in the diagram to the right. The bottom set of three LEDs is the same as used on other boards. The left set is for the PECM software and the right set is for the temperature controller software. Each will go through a separate display on power up and normal operation. The top two sets of four LEDs each are for the operation of each of the two temperature controllers on the front board. Heater 1 is on the left and heater 2 is on the right side of the board.

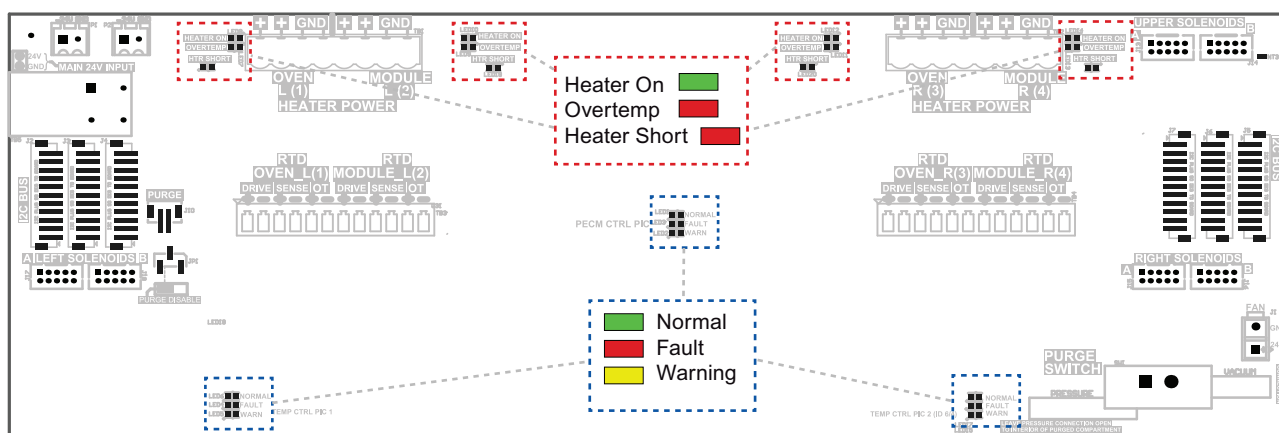
The PECM-DC LED locations are shown below.
